SITE CODE: <b>MZ</b>	DATE OPENED: 3 July	SU No: 19015	MARZUOLO ARCHAEOLOGICAL PROJECT

FORMATION PROCESS:	DEFINITION: Eastern pillar on N edge of trench 1
ANTHROPIC <input checked="" type="checkbox"/> NATURAL <input type="checkbox"/>	SU TYPE: <input type="checkbox"/> DEPOSIT <input type="checkbox"/> CUT <input checked="" type="checkbox"/> STRUCTURAL
	DISTINGUISHED BY: <input type="checkbox"/> COLOUR <input type="checkbox"/> COMPACTION <input type="checkbox"/> COMPOSITION

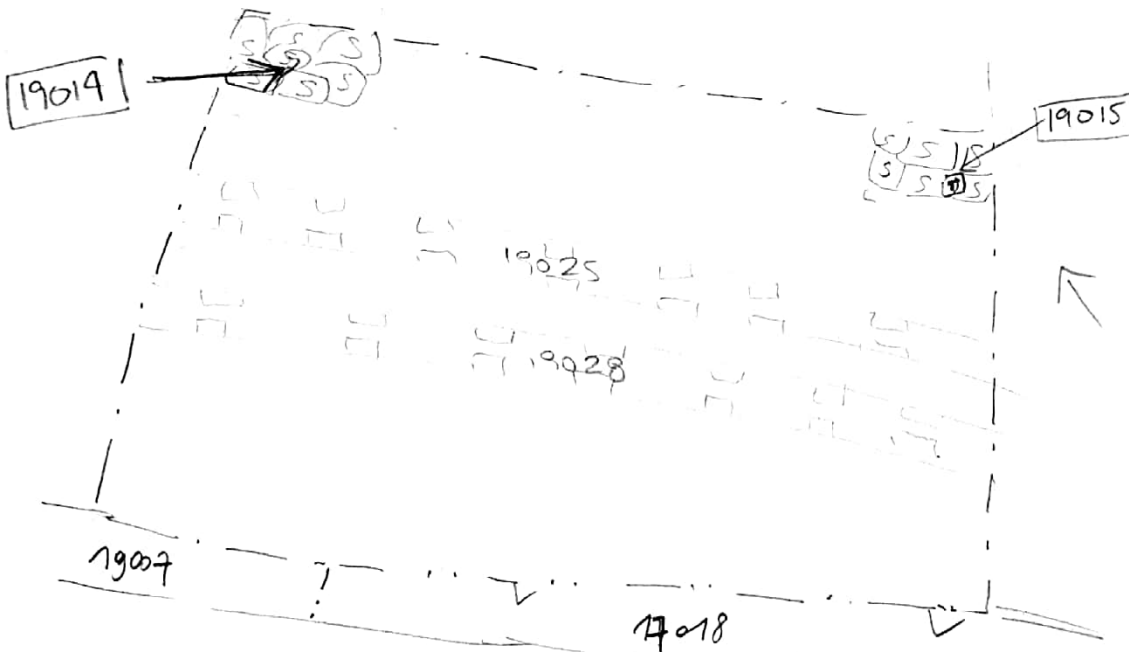
<b>DEPOSIT:</b> 1. Composition (sand/silt/clay) 2. Compaction 3. Colour 4. Clarity of Limits (clear/not clear/exc. lim. for N/S/W/E/depth) 5. Dimensions 6. Method & Conditions	<b>STRUCTURAL:</b> 1. Type (wall, cistern, etc.) 2. Orientation 3. Technique (pisé, ashlar, etc.) 4. Bonding Material 5. # of Coursings 6. Facing/Finish (plaster, etc.) 7. Dimensions 8. Related architectural features	<b>DESCRIPTION:</b> ① Pillar ② NS ③ Rounded stones and tiles ④ Gray mortar ⑤ 4 courses of stones ⑥ NA ⑦ cm 50 x cm 50 ⑧ 19014
---	--	---

**OTHER OBSERVATIONS/COMMENTS:**  
 As usual the foundation trench cut it is not visible

One of two pillars, possibly part of a porch
