SITE CODE: MZ	DATE OPENED: 05 July	SU No: 17126	MARZUOLO ARCHAEOLOGICAL PROJECT

FORMATION PROCESS:	DEFINITION: tile deposit
ANTHROPIC <input checked="" type="checkbox"/> NATURAL <input type="checkbox"/>	SU TYPE: <input checked="" type="checkbox"/> DEPOSIT <input type="checkbox"/> CUT <input type="checkbox"/> STRUCTURAL
	DISTINGUISHED BY: <input type="checkbox"/> COLOUR <input type="checkbox"/> COMPACTION <input checked="" type="checkbox"/> COMPOSITION

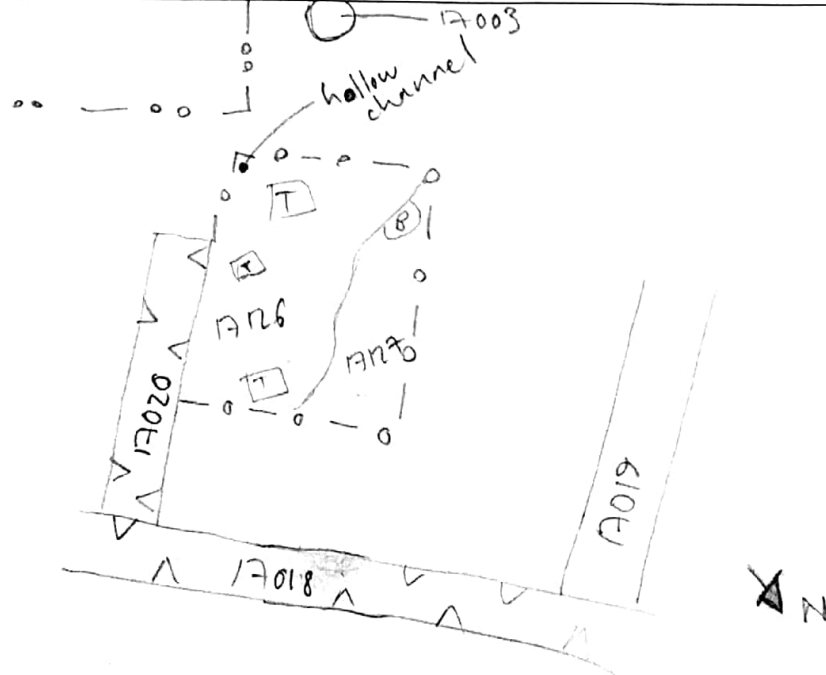
SKETCH OF PLAN **INCLUDE:** 1. North arrow; 2. Dimensions; 3. Sample locations (if relevant); 4. Levels; 5. Grid pts (if relevant); 6. Rise/Drop in surface level; 7. Abutting architecture/Adjacent or relevant nearby features for reference; 8. All SU N°s

orange layer 127 (wattle and daub) covered by tile layer 126. In Northern extent, 126 is especially thin where 127 is more visible underneath. Greater concentration of tiles in NE corner. 126 does not cover extent of trench, western half more orange w/ fewer tile inclusions.

Follow in SE corner - wood inclusions w/ roof continuing into layer beneath Amphora handle continuity from 127 into 126.

INTERPRETATION:
 possible roof collapse (not in situ)
