SITE CODE: MZ	DATE OPENED: 10 July 2018	SU No: 20035	MARZUOLO ARCHAEOLOGICAL PROJECT

DATE CLOSED: 17 July 2018	AREA No: 20000 TR-2	
	INITIAL: N/A

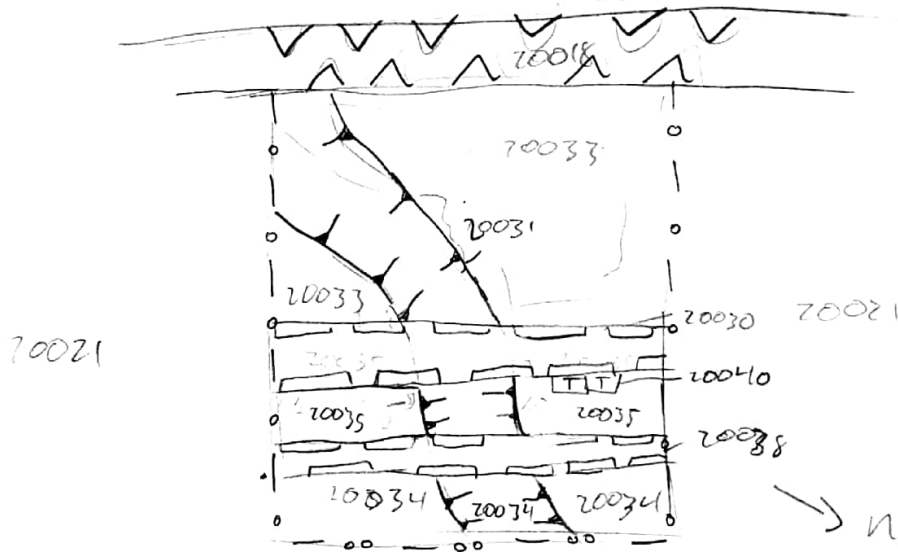
SKETCH OF PLAN

• tiles found beneath 20035, potential cover of drain

• no large tiles found in E part of fill (E of 20031)

- tiles found underneath 20035 indicate a drain cover w of cut 20031
- no large tiles found E of cut
- 20035 is most likely a natural deposit, indicating abandonment; an accumulation after drains were out of use.
