SITE CODE: MZ	DATE OPENED: 29 June	SU No: 17019	MARZUOLO ARCHAEOLOGICAL PROJECT

FORMATION PROCESS: <input checked="" type="checkbox"/> ANTHROPIC <input type="checkbox"/> NATURAL	DEFINITION: TILE WALL
	SU TYPE: <input type="checkbox"/> DEPOSIT <input type="checkbox"/> CUT <input checked="" type="checkbox"/> STRUCTURAL
	DISTINGUISHED BY: <input type="checkbox"/> COLOR <input type="checkbox"/> COMPACTION <input type="checkbox"/> COMPOSITION

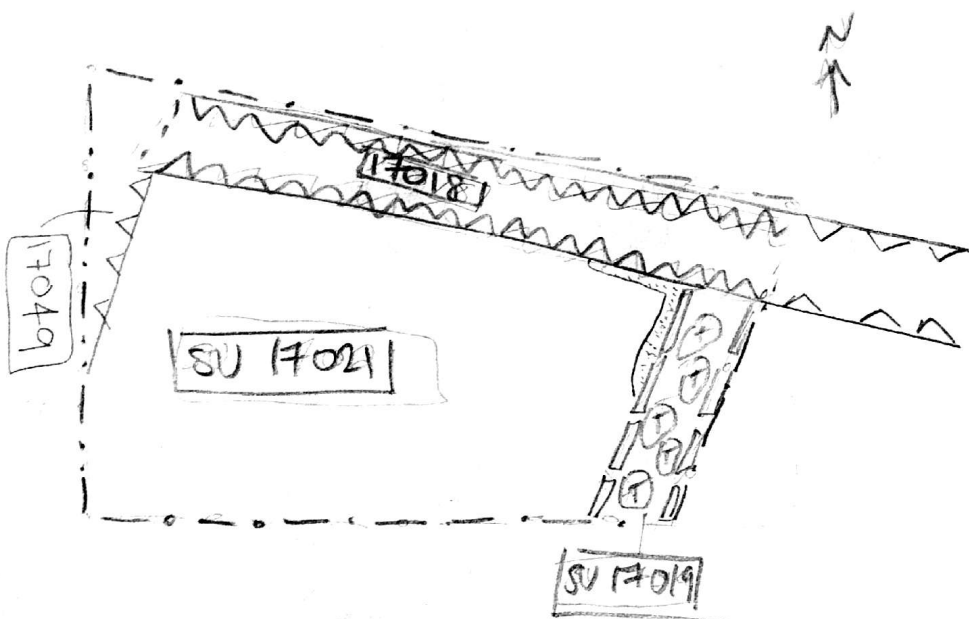
SKETCH OF PLAN INCLUDE: 1. North Arrow; 2. Dimensions; 3. Sample Locations (if relevant); 4. Levels; 5. Grid Pts (if relevant); 6. Rise/Drop in Surface Level; 7. Abutting Architecture/Adjacent or Relevant Nearby Features for Reference; 8. All SU N°s

INTERPRETATION/DISCUSSION:
 Tile wall built at later stage to build a tank(?); Foundation cut 17097 made in chocolate 17100 to construct pisé Foundation with tiled suprastructure, which was lined with cocciopesto. 2 tile stamps [C. DECVM] found in situ in wall.

COMMENTS/OBSERVATIONS:
 Similar walls at Rusellae (+ Santa Marta)
 consist 3 courses of pantiles + their edges
 multiple layers of plaster
 [17056] + [17057] + [17070] underneath the first layer of plaster
 - Tile upper, but pipe lower - packed clay faced w/ plaster
 - Wall built into Foundation trench 17097, filled w/ 17083 = 17085
