SITE CODE: MZ	DATE OPENED: 17 July	SU No: 17086	MARZUOLO ARCHAEOLOGICAL PROJECT
	DATE CLOSED:	SE	
	INITIAL: AK	AREA No: 17000

FORMATION PROCESS: ANTHROPIC <input checked="" type="checkbox"/> NATURAL <input type="checkbox"/>	DEFINITION: bricks east of south of 17002
	SU TYPE: <input type="checkbox"/> DEPOSIT <input type="checkbox"/> CUT <input checked="" type="checkbox"/> STRUCTURAL
	DISTINGUISHED BY: <input checked="" type="checkbox"/> COLOR <input type="checkbox"/> COMPACTION <input checked="" type="checkbox"/> COMPOSITION

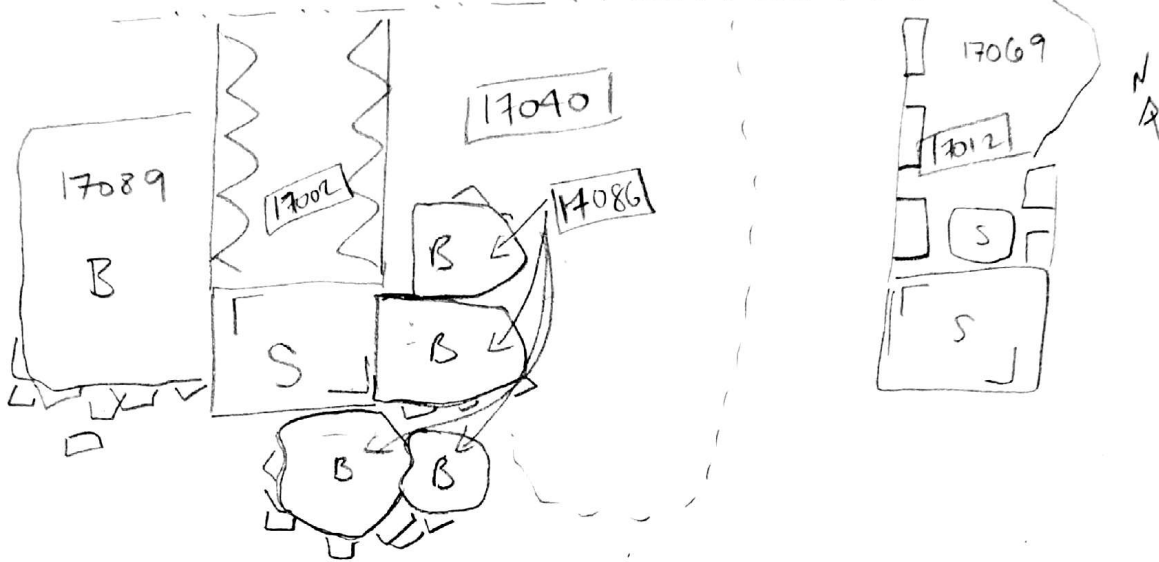
SKETCH OF PLAN

INTERPRETATION/DISCUSSION:
 Low fired bricks abutting east face of wall 17002 and covering structural collapse

Discussion of whether the bricks have been purposefully placed abutting east face of wall (17002) over collapse of structure or whether part of that collapse.

Agreement that bricks cover collapse assoc. with fire and must belong to post collapse use phase (24 July; RGV)
