SITE CODE: <b>MZ</b>	DATE OPENED: 17 July	SU No: 17089	MARZUOLO ARCHAEOLOGICAL PROJECT

FORMATION PROCESS:	DEFINITION: Bricks west of 17002
ANTHROPIC <input checked="" type="checkbox"/> NATURAL <input type="checkbox"/>	SU TYPE: <input type="checkbox"/> DEPOSIT <input type="checkbox"/> CUT <input checked="" type="checkbox"/> STRUCTURAL
	DISTINGUISHED BY: <input checked="" type="checkbox"/> COLOR <input type="checkbox"/> COMPACTION <input checked="" type="checkbox"/> COMPOSITION

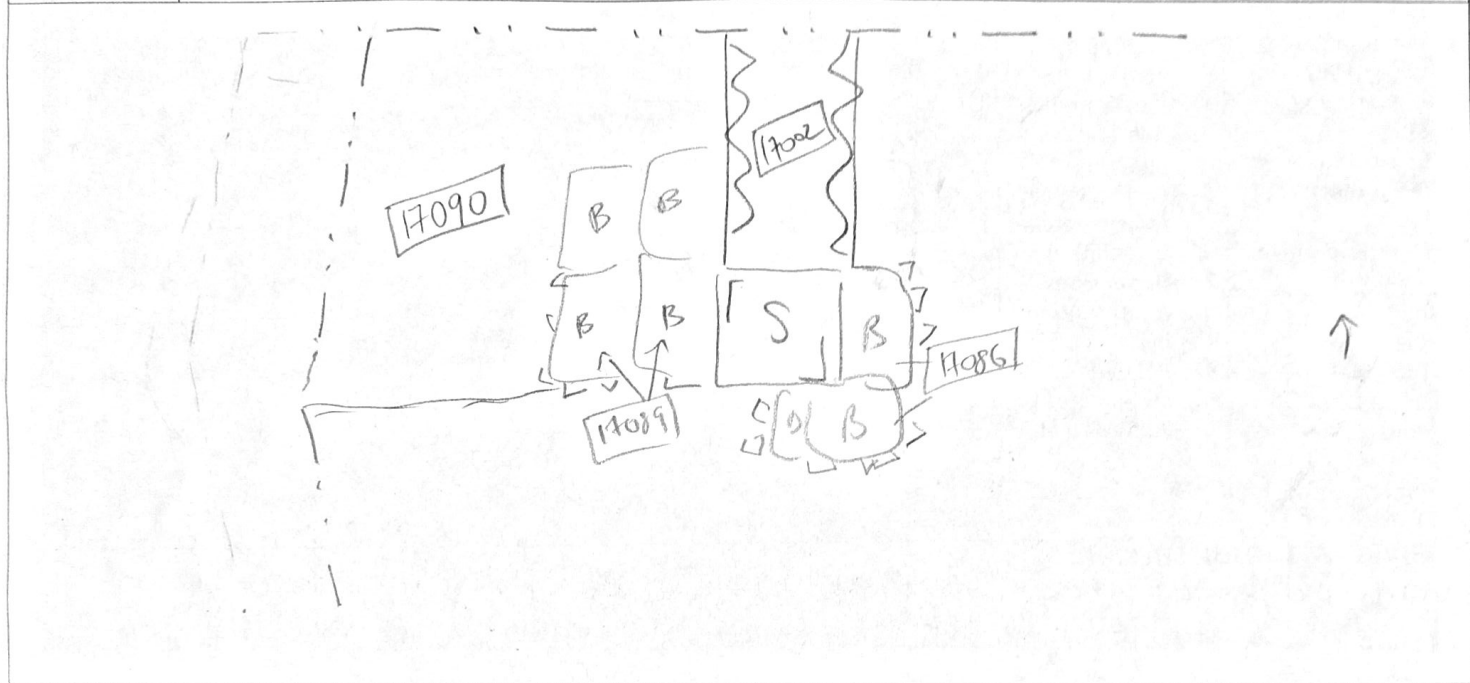
**SKETCH OF PLAN** **INCLUDE:** 1. North Arrow; 2. Dimensions; 3. Sample Locations (if relevant); 4. Levels; 5. Grid Pts (if relevant); 6. Rise/Drop in Surface Level; 7. Abutting Architecture/Adjacent or Relevant Nearby Features for Reference; 8. All SU N°s

**INTERPRETATION/DISCUSSION:**  
 Low fired brick west of wall 17002; probably in phase with 17086 to S and E, as well as brick abutting E face of wall 17012 (17063).  
 Appears to abut wall 17002 and cover a collapse of small store and tiles

**COMMENTS/OBSERVATIONS:**  
 Interpretation unclear:  
 - brick part of structural collapse; collapsed off wall 17002  
 - brick belongs to re-use phase after collapse; purposely placed next to wall - but for what purpose?
