SITE CODE: MZ	DATE OPENED: 21 July	SU N°: 17123	MARZUOLO ARCHAEOLOGICAL PROJECT <small>NAME</small>
	DATE CLOSED: 21 July		
	INITIAL: RGV	AREA N°: 17000

FORMATION PROCESS: ANTHROPIC <input checked="" type="checkbox"/> NATURAL <input type="checkbox"/>	DEFINITION: FOUNDATION between 17002 and 17120
	SU TYPE: <input type="checkbox"/> DEPOSIT <input type="checkbox"/> CUT <input checked="" type="checkbox"/> STRUCTURAL
	DISTINGUISHED BY: <input type="checkbox"/> COLOR <input type="checkbox"/> COMPACTION <input type="checkbox"/> COMPOSITION

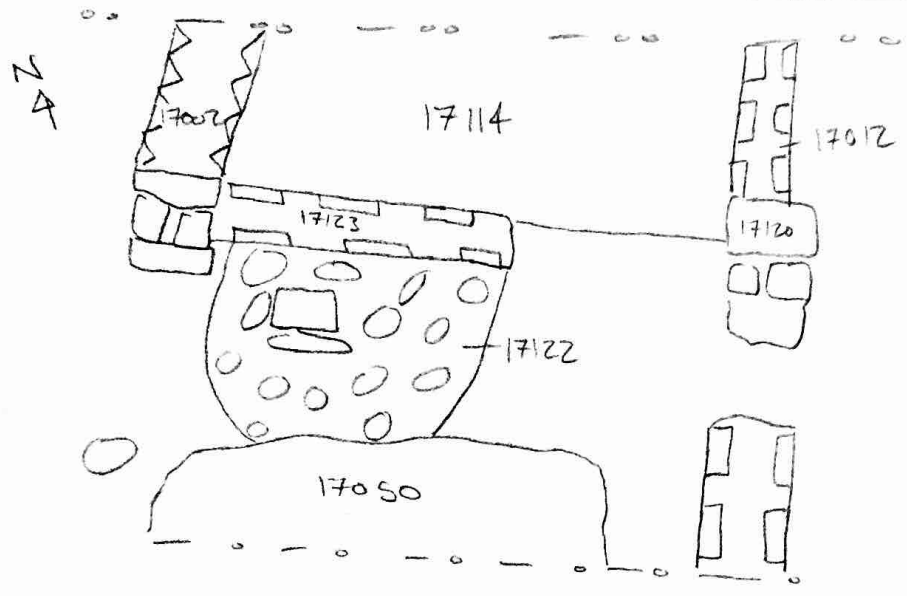
SKETCH OF PLAN INCLUDE: 1. North Arrow; 2. Dimensions; 3. Sample Locations (if relevant); 4. Levels; 5. Grid Pts (if relevant); 6. Rise/Drop in Surface Level; 7. Abutting Architecture/Adjacent or Relevant Nearby Features for Reference; 8. All SU N^os

INTERPRETATION/DISCUSSION:
 Removal of 17042 (bottom of collapse or disturbed occupation level?) revealed alignment of stores in white mortar sitting on top of chocolate 17114 and abutting wall 17002 to East. Foundation for a dividing wall? Threshold for entryway? Stores and tiles continue to south, which may be a surface or collapse assoc with this su.
