SITE CODE: MZ	DATE OPENED: 28 June 2017	SU No: 17003	MARZUOLO ARCHAEOLOGICAL PROJECT <small>(NAME)</small>
	DATE CLOSED: NOT Fully Exc.	AREA No: 17000	
	INITIAL: AK/KG

FORMATION PROCESS: ANTHROPIC <input checked="" type="checkbox"/> NATURAL <input type="checkbox"/>	DEFINITION: Stone Column base
	SU TYPE: <input type="checkbox"/> DEPOSIT <input type="checkbox"/> <input type="checkbox"/> CUT <input checked="" type="checkbox"/> STRUCTURAL
	DISTINGUISHED BY: <input type="checkbox"/> COLOR <input type="checkbox"/> COMPACTION <input checked="" type="checkbox"/> COMPOSITION

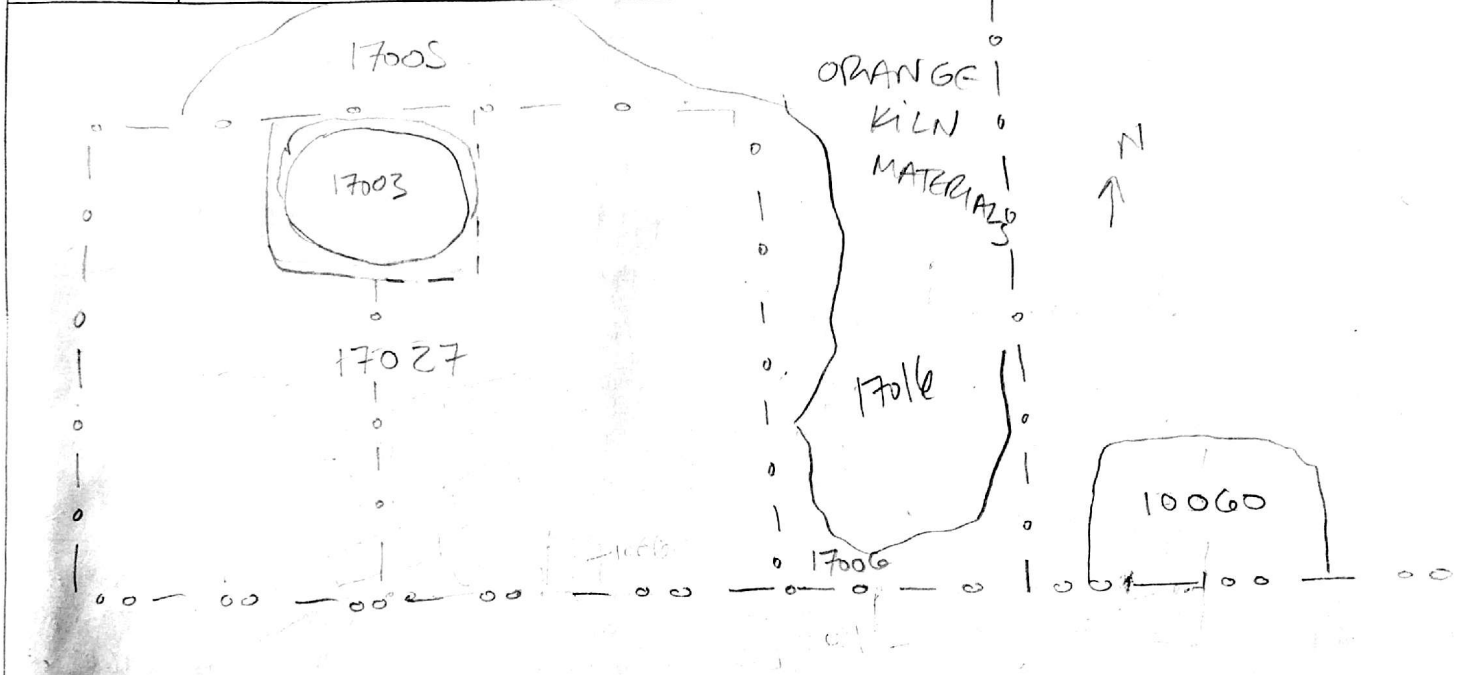
SKETCH OF PLAN INCLUDE: 1. North Arrow; 2. Dimensions; 3. Sample Locations (if relevant); 4. Levels; 5. Grid Pts (if relevant); 6. Rise/Drop in Surface Level; 7. Abutting Architecture/Adjacent or Relevant Nearby Features for Reference; 8. All SU N°s

INTERPRETATION/DISCUSSION:
 Stone column base (ionic?); rounded base on square plinth. Carved from red conglomerate stone similar to end stones of walls in 17000 (17002 & 17012) and 16000, as well as RPP Prer (10060) — to SE and MAP prer (16036). Butted by 17027 (strange dark soil suggestive of cut around column) and 17044. Probably in phase w/ pebble surface 17052. Covers shallow foundation 17059.

COMMENTS/OBSERVATIONS:
 Could this be a central pillar to a massive kiln? - NO
 This base also lines up with RPP's pier 10060
 Most likely column base to support porch or portico and can be associated w/ original occupation of structure (pre-fire destruction?)
