SITE CODE: MZ	DATE OPENED: 1 July	SU No: 17059	MARZUOLO ARCHAEOLOGICAL PROJECT
	DATE CLOSED: 3 July	8c	
	INITIAL: [signature]	AREA No: 17000

FORMATION PROCESS: ANTHROPIC <input type="checkbox"/> NATURAL <input type="checkbox"/>	DEFINITION: column foundation mortar
	SU TYPE: <input type="checkbox"/> DEPOSIT <input type="checkbox"/> <input type="checkbox"/> CUT <input type="checkbox"/> STRUCTURAL
	DISTINGUISHED BY: <input type="checkbox"/> COLOR <input checked="" type="checkbox"/> COMPACTION <input checked="" type="checkbox"/> COMPOSITION

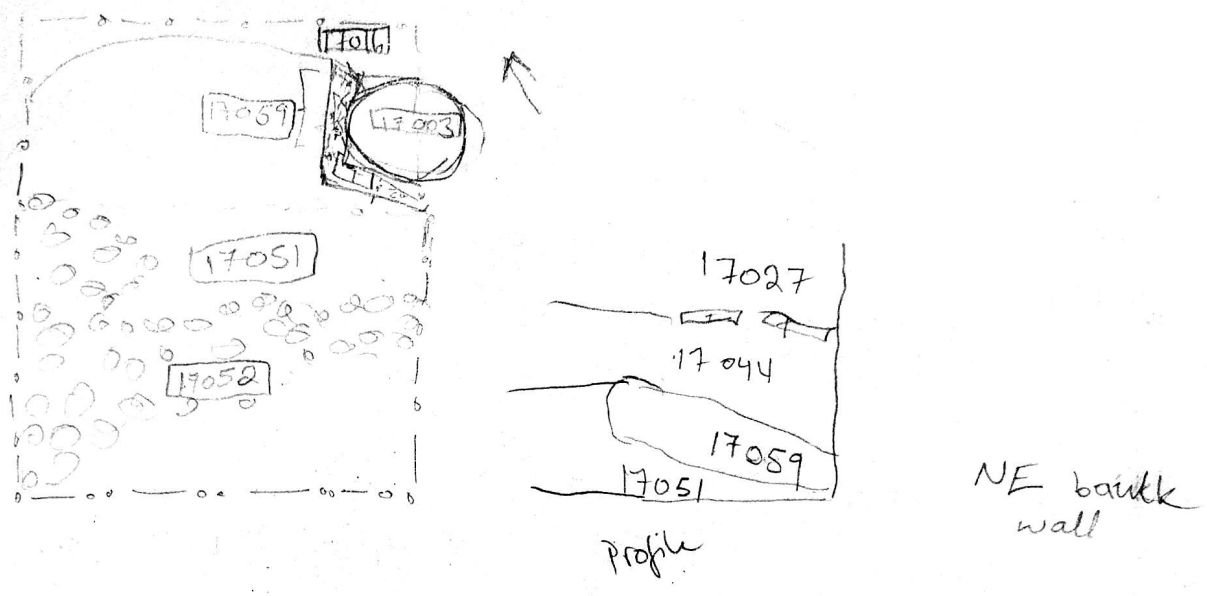
SKETCH OF PLAN INCLUDE: 1. North Arrow; 2. Dimensions; 3. Sample Locations (if relevant); 4. Levels; 5. Grid Pts (if relevant); 6. Rise/Drop in Surface Level; 7. Abutting Architecture/Adjacent or Relevant Nearby Features for Reference; 8. All SU Nos

INTERPRETATION/DISCUSSION:
Mortary foundation of column 17003. Cut (17066) into soil matrix 17051. Not as well made as mortar/stone foundation of the pier from 16000 (M22016); stones irregularly sized and place, mortary material quite friable. Did not excavate lower than this layer

COMMENTS/OBSERVATIONS:
 On surface extent appeared parallel to column base; upon excavation found the cut/fill was askew about 30° from the line of the base. Noticed when cleaning bank wall that context extends higher to the NW.
